XC2700 Derivatives

16/32-Bit Single-Chip Microcontroller
with 32-Bit Performance

Errata Sheet

V1.7 2014-10

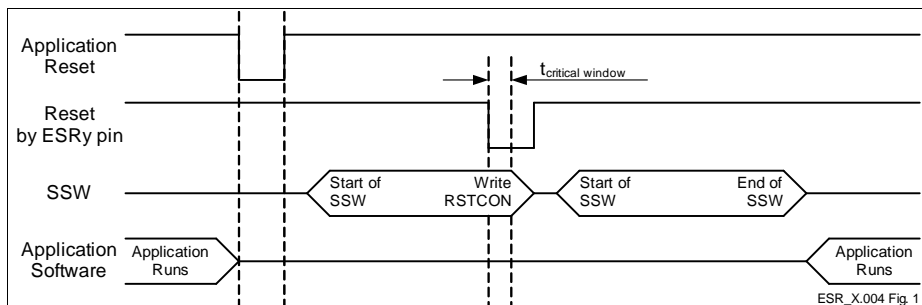
Figure 1 Critical application reset sequence

ESR X.004 Wrong Value of SCU_RSTCONx Registers after ESRy Application Reset

SCU_RSTCONx registers are reset only by Power-On, but they may be wrongly affected after a second application reset requested by an ESRy pin. This may lead to the SCU_RSTCONx register values being set to zero, which could unexpectedly disable reset sources within the user application. The conditions which lead to this behavior are:

1. First, an application reset by SW (software), CPU (Central Processing Unit), MP (Memory), WDT (Watchdog Timer) or ESRy (External Service Request y) occurs.
2. Following this, an application reset on an ESRy pin occurs.
3. If the above mentioned ESRy reset occurs during a critical time window of the SSW (startup software), then it's possible that the application will operate with the wrong SCU_RSTCONx register value. The critical time window occurs when the SSW is writing the SCU_RSTCONx registers, and at the same time, the ESRy reset request is processed by the reset circuitry. The width of this critical window $f_{critical\ window}$ is less than 13 cycles.

- Initialize `SCU_RSTCONx` registers by user software after any reset, or
- assure that a second application reset request with an ESR pin does not occur during the critical time window.

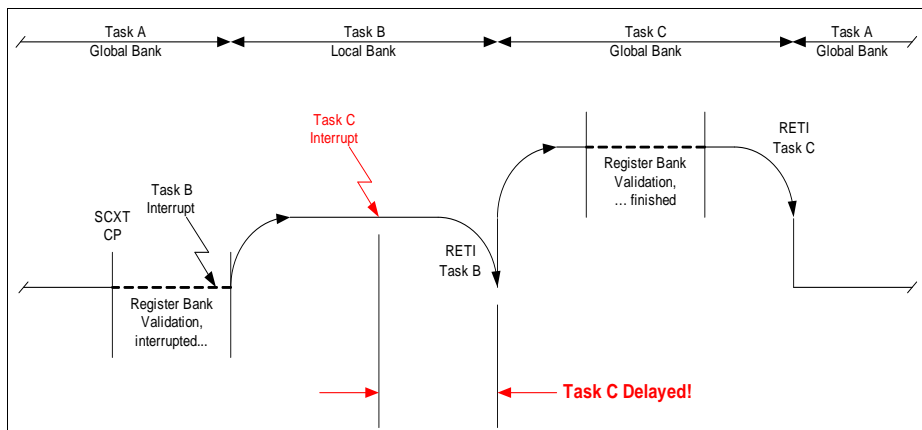
Figure 2 Example for Case 2: Interrupt Service for Task C delayed

- The Context Pointer CP is written to (e.g. by POP, MOV, SCXT ... instructions) within a routine (Task A) that uses a **global** register bank (bit field PSW.BANK = 00_B), i.e. the context for this routine will be modified,
- This context switch procedure (19 cycles) is interrupted by an interrupt request (Task B) which is programmed (with GPRSELx = 1X_B) to automatically use one of the **local** banks via the bank selection registers BNKSEL0...3 (i.e. the interrupting routine has a priority level ≥ 12),
- Before the corresponding interrupt service routine is finished, another interrupt request (Task C) occurs which is programmed (with GPRSELx = 00_B) to automatically use the **global** bank via the bank selection registers BNKSEL0...3 (i.e. the interrupting routine has a priority level ≥ 13).

In this case service of this interrupt request (for Task C) is delayed until bit field PSW.BANK becomes 00_B after executing the RETI instruction at the end of the routine (Task B) using the local bank.

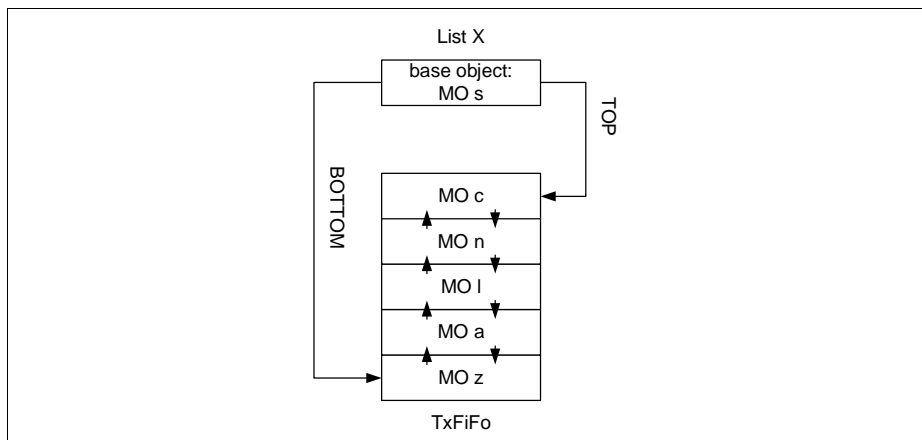
Figure 3 FIFO structure

After the successful transmission of a Tx FIFO element, a Tx overflow interrupt is generated if the FIFO base object fulfils these conditions:

If Tx FIFO overflow interrupt needed, take the FIFO base object out of the circular list of the Tx message objects. That is to say, just use the FIFO base object for FIFO control, but not to store a Tx message.

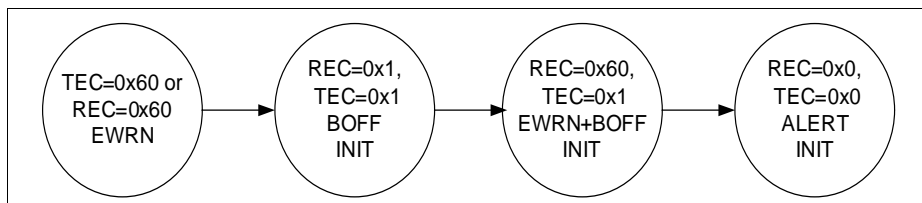
Figure 5 Alert Interrupt Behavior in case of Bus-Off

MultiCAN AI.H007 Alert Interrupt Behavior in case of Bus-Off

The MultiCAN module shows the following behavior in case of a bus-off status:

When the threshold for error warning (EWRN) is reached (default value of Error Warning Level EWRN = 0x60), then the EWRN interrupt is issued. The bus-off (BOFF) status is reached if TEC > 255 according to CAN specification, changing the MultiCAN module with REC and TEC to the same value 0x1, setting the INIT bit to 1_B, and issuing the BOFF interrupt. The bus-off recovery phase starts automatically. Every time an idle time is seen, REC is incremented. If REC = 0x60, a combined status EWRN+BOFF is reached. The corresponding interrupt can also be seen as a pre-warning interrupt, that the bus-off recovery phase will be finished soon. When the bus-off recovery phase has finished (128 times idle time have been seen on the bus), EWRN and BOFF are cleared, the ALERT interrupt bit is set and the INIT bit is still set.
