OPTIREG™ PMIC TLF35584QVHSx

Functional Safety Power Management IC

Errata Sheet

Reference: Datasheet Rev 2.0 (TLF35584QVHSx)

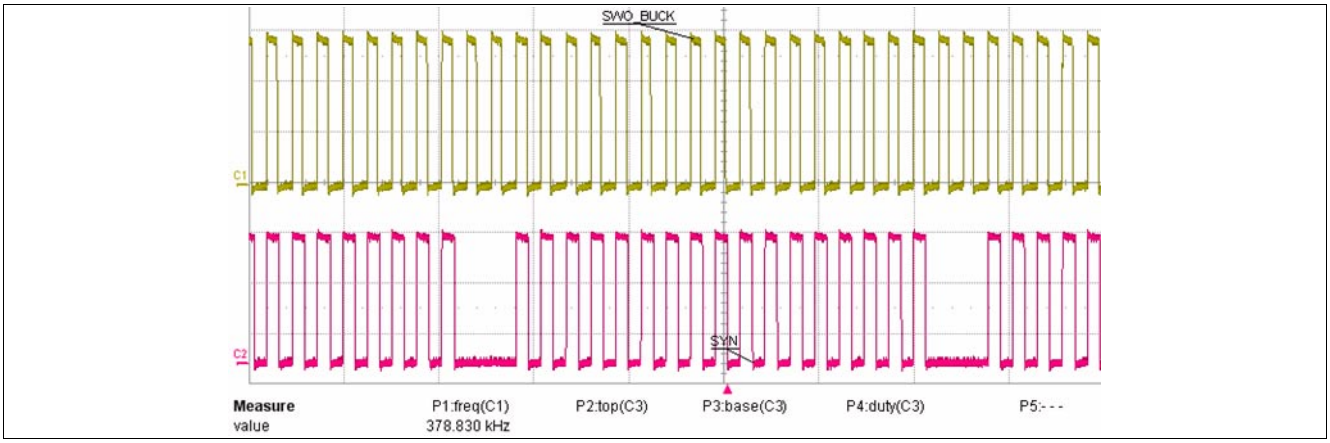
Number	Function	Description
1	Synchronization output signal with active spread spectrum	• There is a weakness of the D11-step silicon for the synchronization output signal for the optional core voltage regulator during activated spread spectrum. • In case the synchronization output SYN is being used and connected to an external switched mode power supply, it should be taken into consideration that the SYN-output signal might be interrupted unintentionally in a random way for activated spread spectrum. • In Figure 1 and Figure 2 it is shown how the signal of SYN might look like. The figures have been generated using the synchronization without phase shift (DEVCFG2.ESYNPHA = 0). For this configuration the SYN output signal will stuck to low signal temporarily. For configuration with 180° phase shift (DEVCFG2.ESYNPHA = 1) the stuck signal would be high level.

Figure 1 Interrupted SYN output for activated spread spectrum (FRE pin to GND - LF)

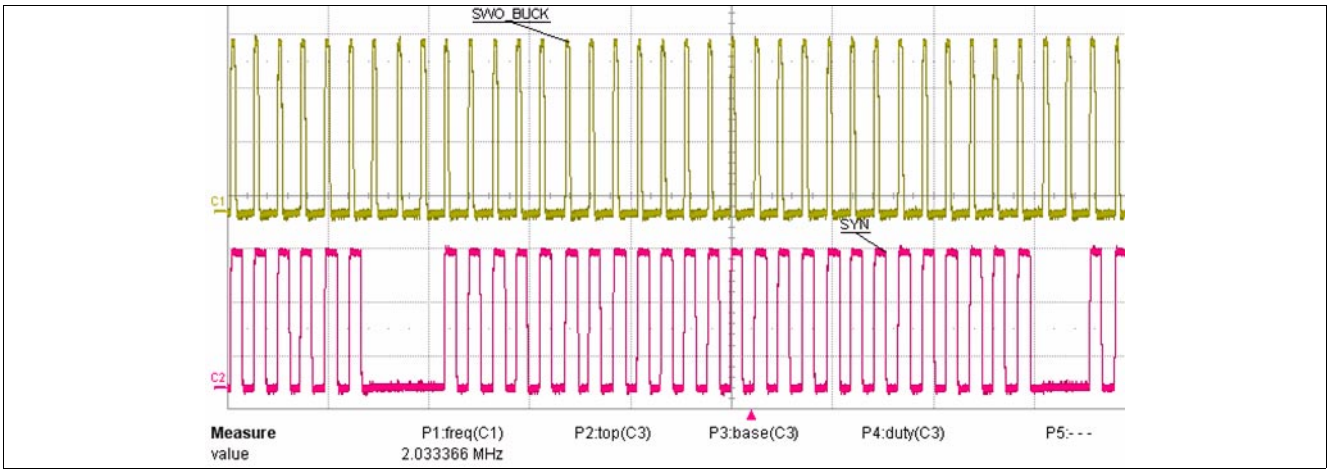
Figure 2 Interrupted SYN output for activated spread spectrum (FRE pin open - HF)

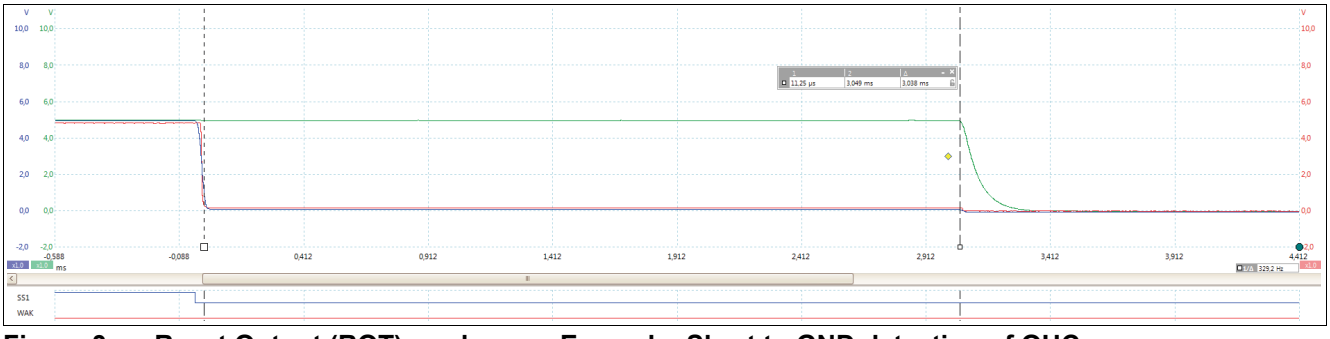
Number	Function	Description
1	Reset output ROT behavior in Move-to-FAILSAFE conditions	• There is a weakness of the D11-step silicon related to the reset output pin ROT, in case the TLF35584 moves to FAILSAFE state. In a safety context the reset function and the reset output ROT are considered to be QM, accordingly safety is not affected. • The output driver of the open drain transistor in the reset output ROT is disabled together with the microcontroller supply LDO (QUC). According to the fact that the QUC is disabled/switched off in case of a Move-to-FAILSAFE event, the reset output is not longer pulled to low signal and is pulled up to QUC. As the QUC is disabled and the output cap is discharged by the load and an internal active pull-down of ~80 Ω, this is reflected in a transient behavior which is shown in the figures below. The observation and relevance strongly depends on the failure case and its boundary conditions. These conditions are elaborated in the following list. – QUC shorted to GND: The voltage monitoring detects the UV and pulls down ROT. SS1/2 are going low and application is in safe state. QUC is shorted to GND and has 0V accordingly, but provides current (still enabled). After typ. 3ms TLF35584 moves to FAILSAFE state and disables the LDO and resets the output driver of ROT. Due to the short to GND ROT stays low as it is pulled to QUC. (no problem) Please refer to **Figure 3**. – QUC overloaded by current. The voltage monitoring detects the UV due to the decreased output voltage by current limitation or dropout voltage (only without boost) and pulls down ROT. SS1/2 are going low and application is in safe state. Due to the assertion of ROT the microcontroller is switched off and decreases its current consumption dramatically. The output voltage of QUC might recover into valid voltage range and the TLF35584 restarts in INIT state. (no problem) – Continuous UV or short to GND on QST or VCI: The voltage monitoring detects the UV on the respective rail and pulls down ROT. SS1/2 are going low and application is in safe state. QUC continues to regulate to its nominal output voltage. After typ. 3ms TLF35584 moves to FAILSAFE state and disables all LDO and resets the output driver of ROT. The reset output might be pulled up to the discharging QUC (by the attached load and an active pull-down of ~80 Ω). This might result into a temporary high level at ROT during the shutdown transition. A undervoltage monitoring of the microcontroller could prevent undesired start of the microcontroller operation. Please refer to **Figure 4**. – Continued on the next page.

Figure 3 Reset Output (ROT) weakness - Example: Short to GND detection of QUC

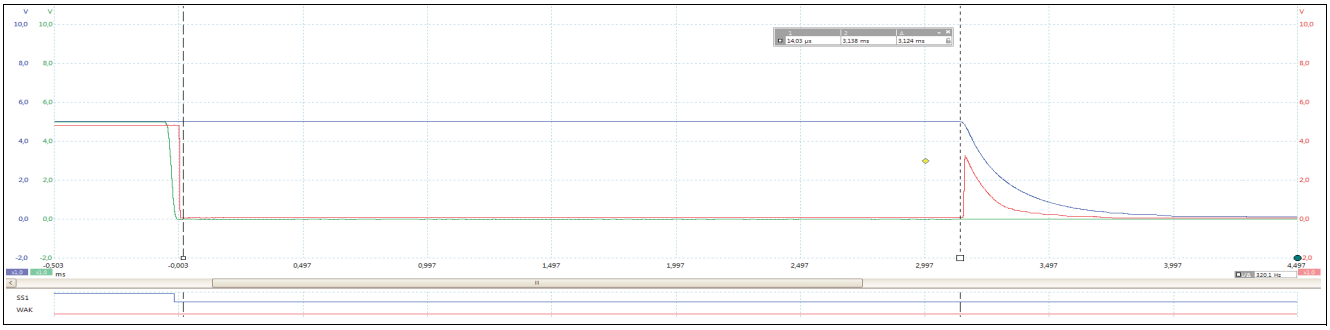
Figure 4 Reset Output (ROT) weakness - Example: Short to GND detection of QST (or VCI)

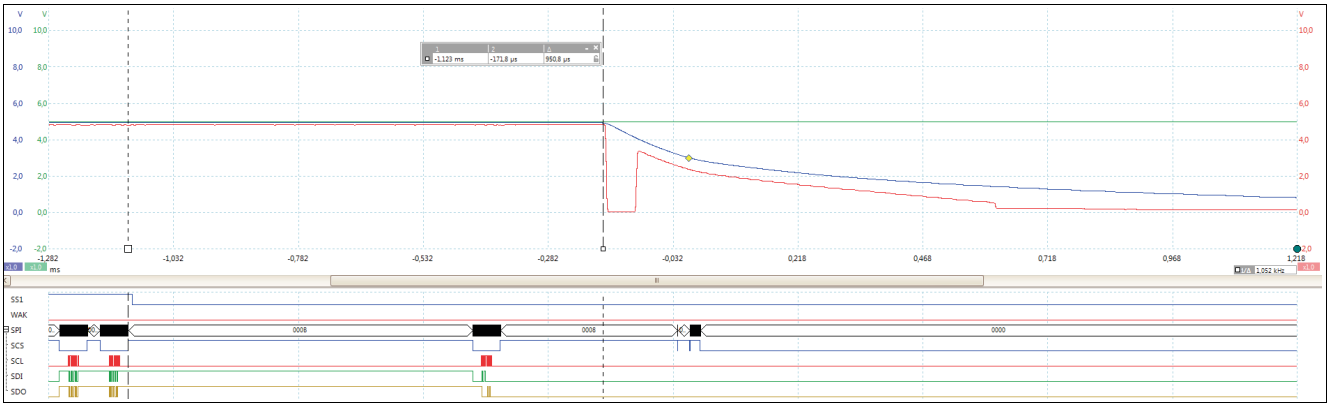
Number	Function	Description
1 (cont'd)	Reset output ROT behavior in Move-to-FAILSAFE conditions (cont'd)	• Continued: – QUC shorted to an higher voltage rail: The voltage monitoring detects the OV on the QUC rail and SS1/2 are going low and application is in safe state. TLF35584 will move to FAILSAFE which is disabling QUC as well as all other regulators and activates the active pull-down of ~80 Ω on QUC output, trying to discharge the rail. The FAILSAFE state disables also the output driver of ROT. The reset output might be pulled up to QUC. This might result into a high level at ROT during presence of the external overvoltage. Still the application will be safely shut down during in this case by SS1/2. Please refer to **Figure 5**.
2	Reset output ROT behavior for Move-to-STANDBY transitions	• There is a weakness of the D11-step silicon related to the reset output pin ROT, in case the TLF35584 moves to STANDBY state. In a safety context the reset function and the reset output ROT is considered to be QM, accordingly safety is not affected. • The output driver of the open drain transistor in the reset output ROT is disabled shortly after the microcontroller supply LDO (QUC). According to the fact that the QUC is disabled/switched off at the point in time when the device enters into STANDBY state (transition delay time expired or in case of QUC current monitoring usage after a decrease below the current threshold), the reset output shortly pulled to low, but pulled up to the output voltage of QUC right after. Nevertheless the output of QUC is actively discharged by the load and an internal active pull-down of ~80 Ω, this is reflected in a transient behavior which is shown in **Figure 6** below.

Figure 6 Reset Output (ROT) weakness - Example: STANDBY transition

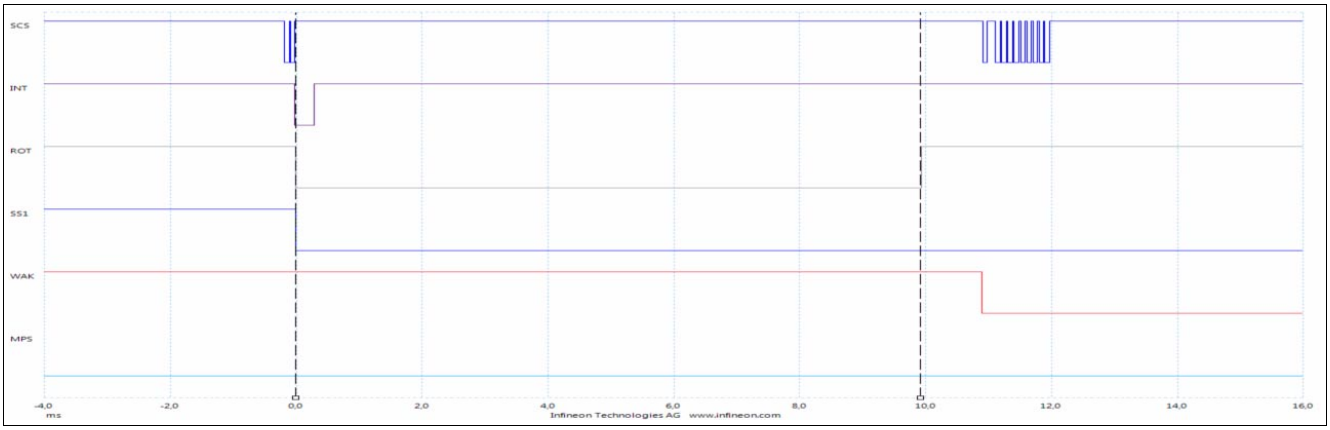
9	Microcontroller programming support (MPS) influence to state transition NORMAL/WAKE to STANDBY	• The chapter 11.7 in the Datasheet Rev 2.0 (TLF35584QVHSx) describes influences to the overall device behavior of the TLF35584. Beside the described differences there is a unintended influences to the device behavior in case of microcontroller programming support being active (MPS-Pin high) for the movement NORMAL/WAKE to STANDBY. – For the particular case of an interrupted state transition from NORMAL/WAKE to STANDBY due to a wake-up event by WAK (level) or ENA(edge) during the transition, the TLF35584 is not triggering ROT to low when moving to INIT state. Accordingly the behavior with and without MPS being activated can be compared by **Figure 7** and **Figure 8**. Nevertheless the interrupted transition is triggering in both cases an interrupt event and reports the interrupted state transition by the interrupt register IF.SYS and the subsequent diagnostic register SYSSF.TRFAIL.

Figure 7 Interrupted state transition NORMAL-STANDBY (MPS pin set low)

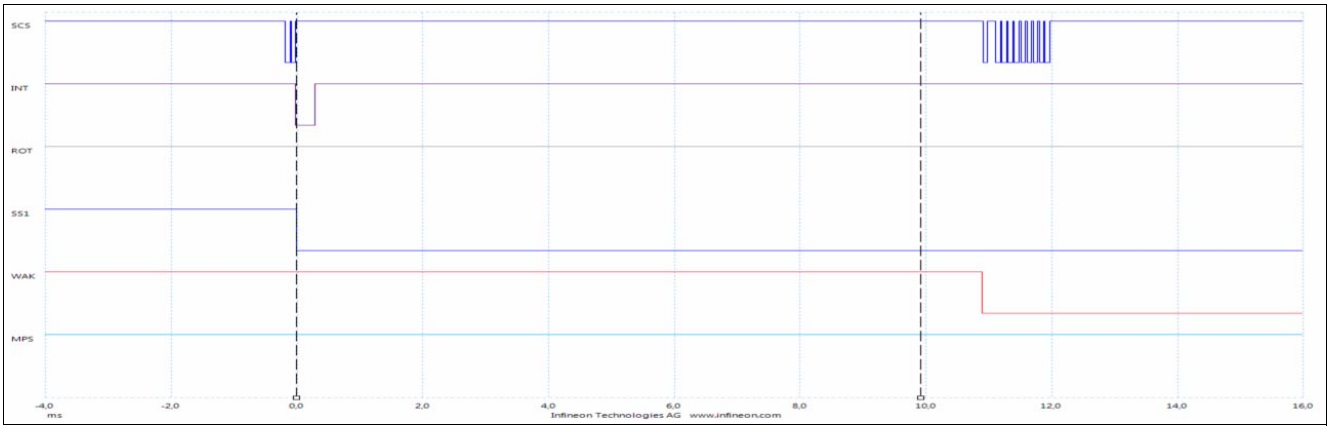
Figure 8 Interrupted state transition NORMAL-STANDBY with active programming support (MPS pin set high)
