Excalibur EPXA4 Devices

November 2002, ver. 1.2

Errata Sheet

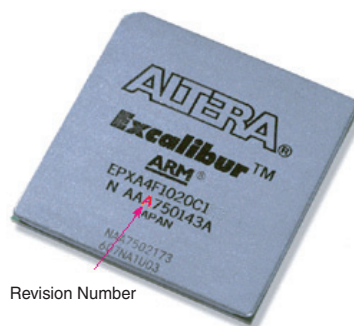
Figure 1. Identify Revision A Devices

This errata sheet provides updated information about the Excalibur™ EPXA4, revision A (see [Figure 1](#)) Devices.
